ELECTROMAGNETIC COMPATIBILITY OPERATIONAL PROBLEMS
ABOARD THE APOLLO SPACECRAFT TRACKING SHIP

By: Mr. R. Henkel and Mr. D. Mealey, Convair division of General Dynamics

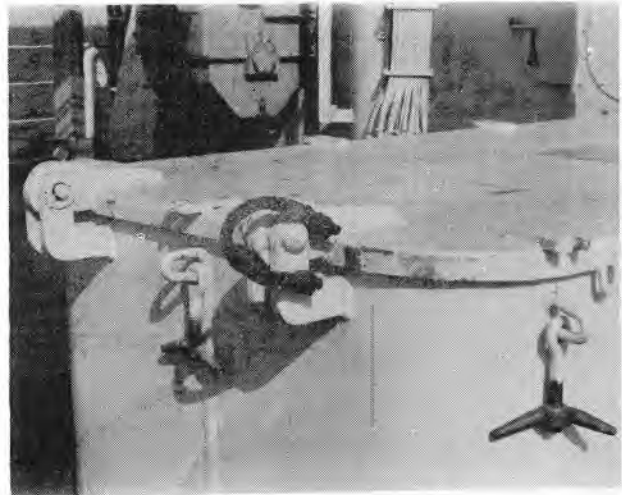
The first indication of the severity of the topside illumination occurred when the HF transmitters were operated into the main deck helical antennas. Simultaneously with this operation, one of the watertight metal doors became a shock hazard, resulting in two instances of shock. The metal hinges did not make adequate electrical contact between the door and the rest of the structure throughout the door's complete swing. To prevent recurrence, ground straps were installed on all topside doors, hatchcovers, and nearly all other hinged devices. (Figures 1, 2, and 3).

Figure 1. Ground Strap on Hatch Cover

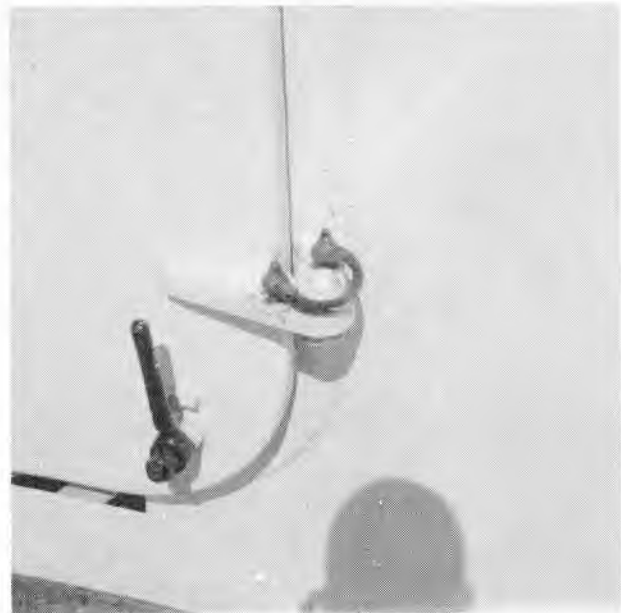
Figure 2. Ground Strap on Water Tight Door

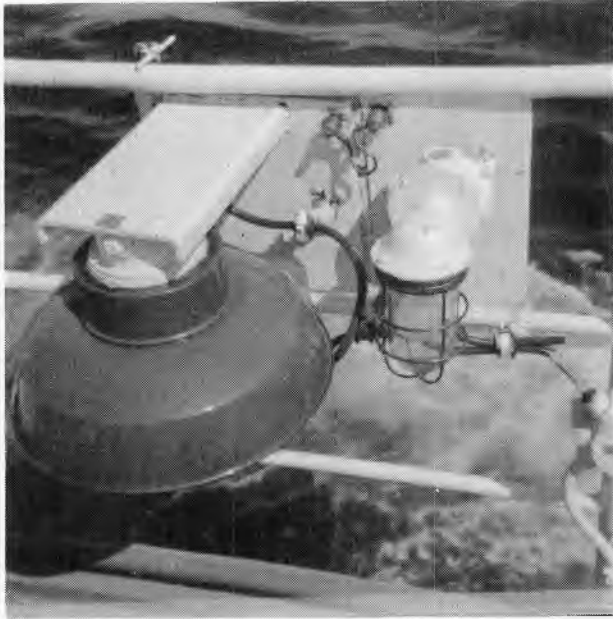
Figure 3. Ground Strap on Hinged Side Light

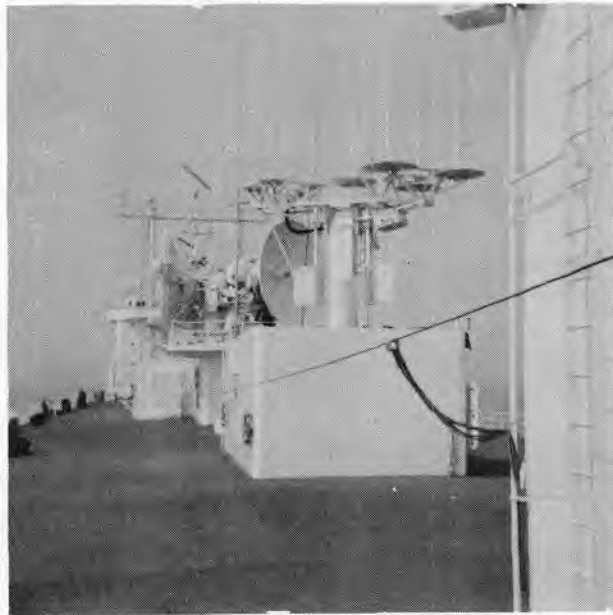
A second problem occurred when a safety guide cable, extending from the aft superstructure to a forward deck house, absorbed enough energy from the helical transmitting antenna to become heated and melt a piece of nylon rope that was lying over it. The cable, a marine safety requirement, was for the purpose of guiding sailors on deck during rough seas. Following the rope-melting incident, the requirement for a safety cable was re-examined, and the cable removed (Figure 4).

Figure 4. Rough Sea Safety Cable Removed After Absorbing HF Energy From Helical Antenna

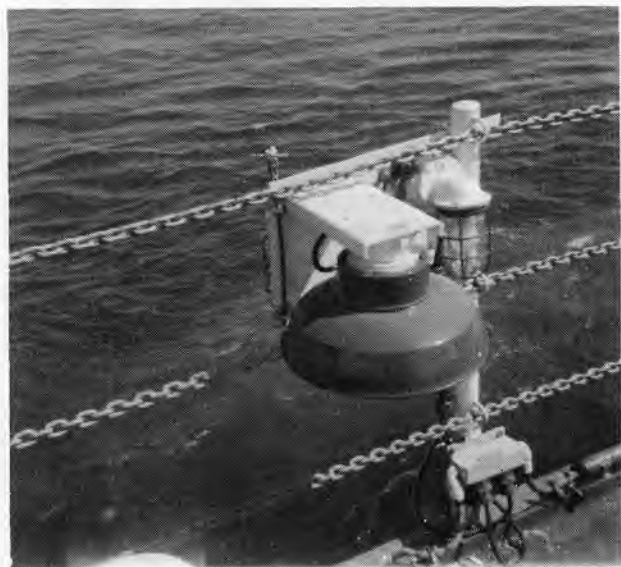
HF transmission. When the HF transmitters were put on the air the noise level in the telemetry receivers increased about 20 to 30 db — a result of the safety barrier chains installed on the weather decks to prevent crew members from being washed overboard. Generally the safety barriers are permanent guard rails, welded in place. However, where the rails must be removable to provide normal ship operations, a chain is required. Another requirement is that at least some of the chains must be quickly removable to permit lifeboat access in event of an emergency. Most of these chains are attached to an eyelet at one end and have a clip at the opposite end. Being slack, the chains swayed with the roll of the ship; in addition, those in the after parts of the ship vibrated excessively due to the vibration caused by the ship's screw.

The motion of the chains created, in effect, a small "switch" at each link-to-link connection. Each of these "switches" operated for the most part, independently of the others in time. Where the chains were illuminated with RF each link became an interference generator, providing (1) broad band interference detected in the 200 to 400 MHz region, and (2) strong harmonics of the impinged RF, detected as high as S-Band. If two frequencies simultaneously excited the chain then broad-band noise plus an entire family of intermodulation products were generated (Figure 5).

Figure 5. Barrier Chains on Outside of Ship Producing Harmonics and Intermodulation Products.

When it was first established there could be no simultaneous operation of transmitters and receivers due to this chain-generated interference, the chains were made taut by tying them with cords, thus preventing the intermittent contact between links. The results were amazing. The environmentally generated noise was reduced to a level that permitted continuation of the tests being conducted at that time.

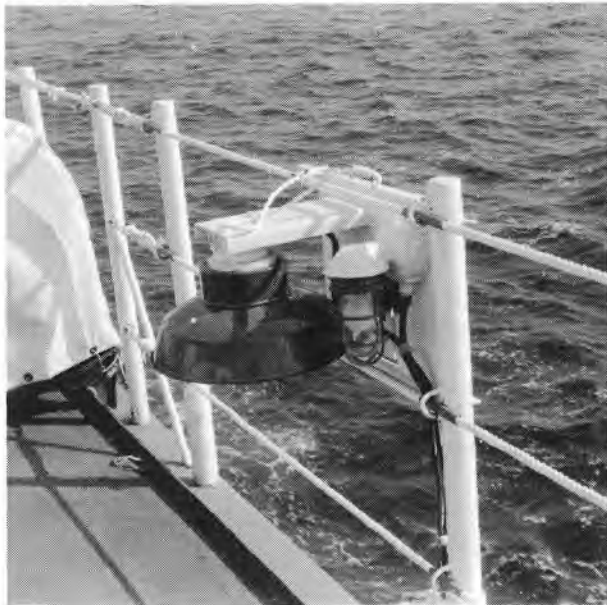
Figure 6. Dacron Rope Replaced the Safety Barrier Chains to Prevent the Production of Harmonics and Intermodulation Products.

The final solution to this chain generated interference problem was securance of an approval by the Coast Guard to replace the chains with a chemical line similar to Dacron (Figure 6).

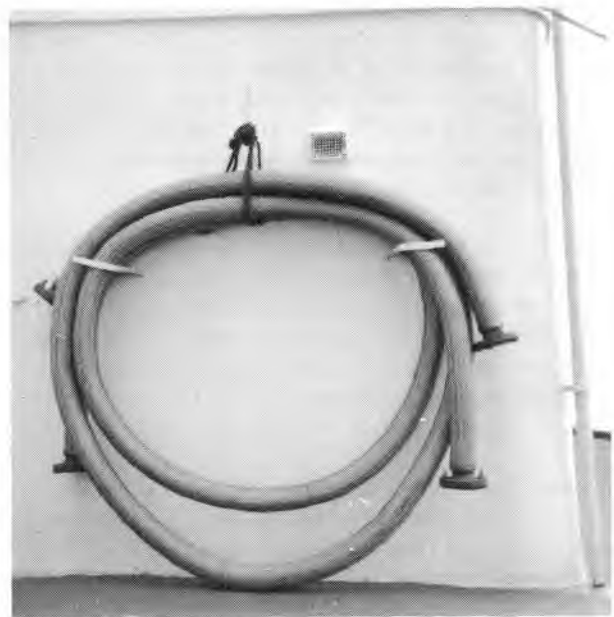
Figure 7. Flexible Vent Hose Stowed Topside was Relocated for Storage Inside.

In addition to removing the topside chains many other items stowed on weather decks were relocated inboard. Items that could not be relocated or removed were secured against intermittent contact with hand lines. Procedures were documented in a Ship's Marine Crew Manual for prevention of interference generation through proper maintenance (Figures 7 and 8).

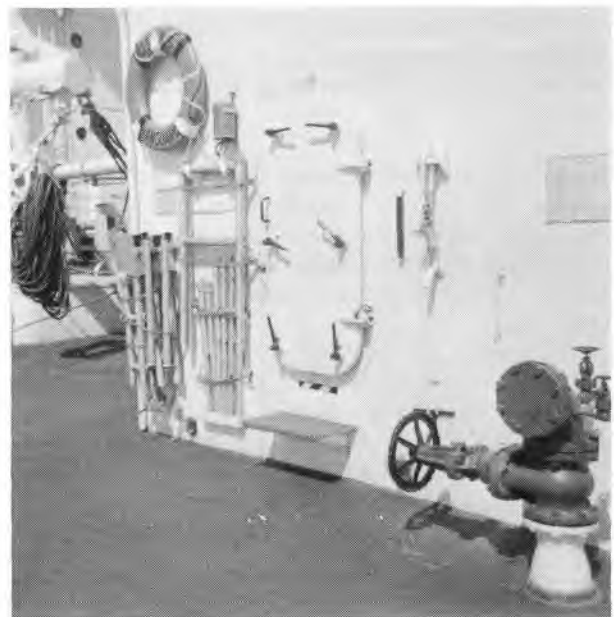
Figure 8. Ladder Accessories Stowed Topside were Relocated Inside the Door.

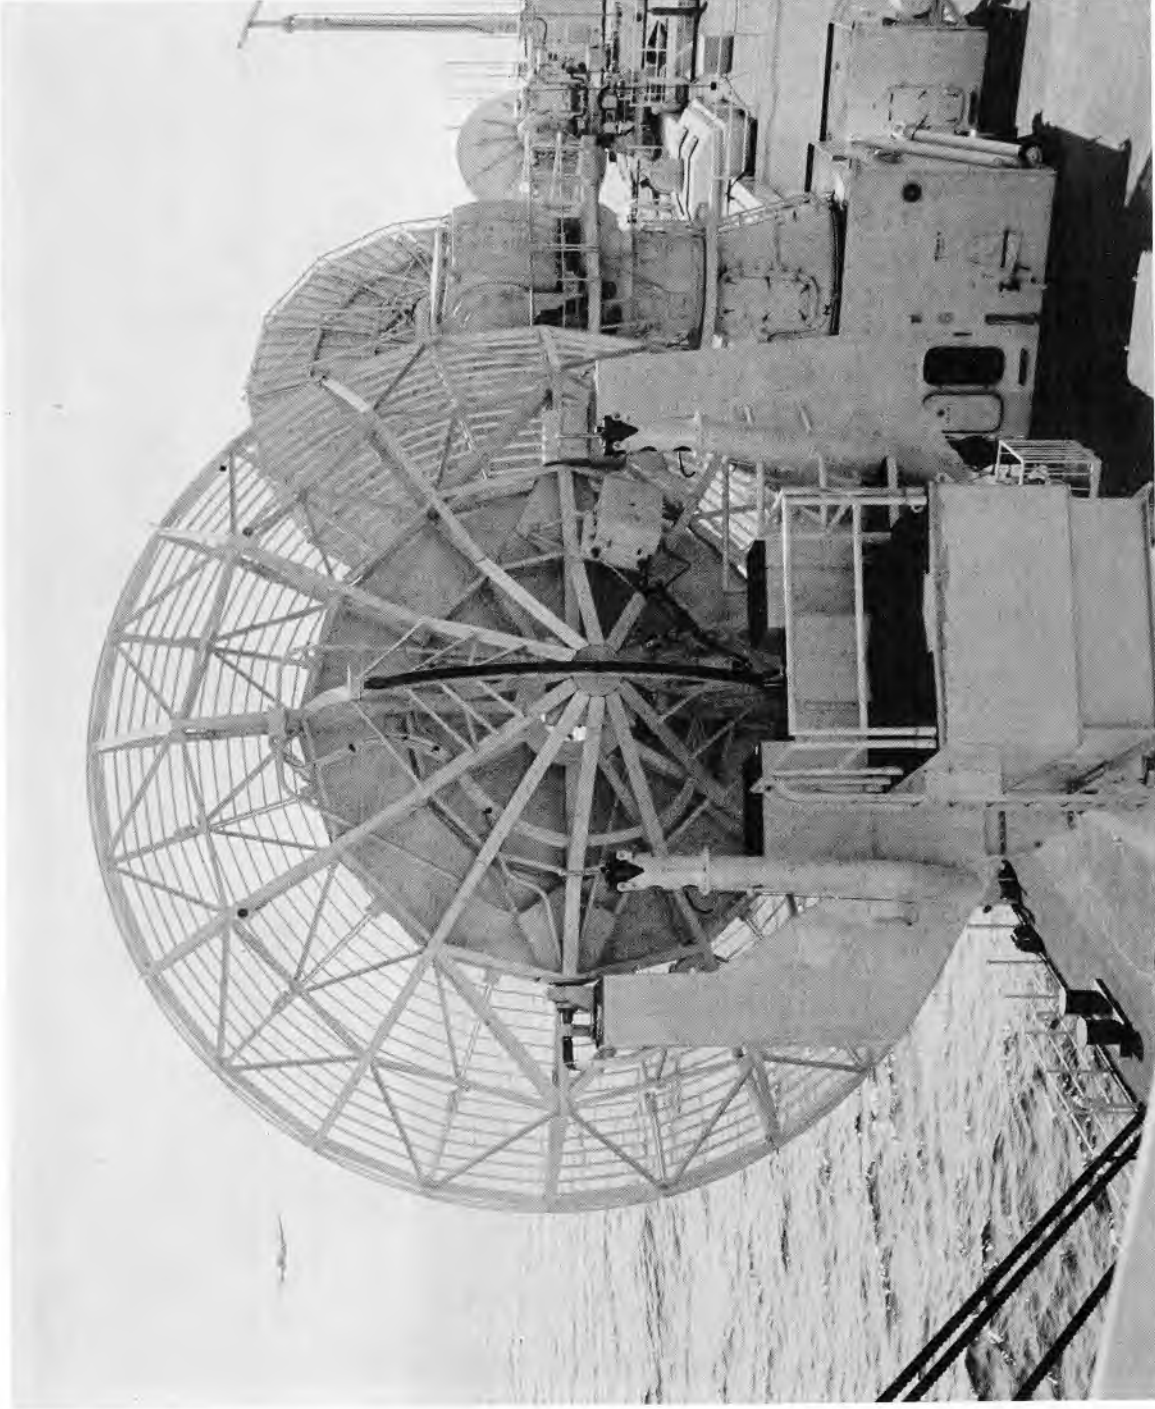
Another troublesome area in the telemetry antenna was impulse interference associated with the roll of the ship. As it rolled from side to side a high level, single shot impulse was detected in nearly all receivers. At times the level was high enough to upset teletype reception. At other times the noise was not present at all. In trying to use the directional qualities of the telemetry antenna to locate the source it was found that the interference was a function of the position of the telemetry antenna itself.

Trouble shooting with a noise and field intensity meter identified the source as the pinion and sector gear that position the antenna in elevation. Backlash between these two gears, necessary to prevent excessive wear, was allowing the gears to make intermittent contact and thereby generate a large RF transient. Wiping the sector gear clean and mounting a brush on the pinion gear solved the problem (see Picture 3 in the Appendix).

Picture 3. Telemetry Antenna Showing Elevation Gear. Intermittent Contact Between the Mating Gear Teeth Generated Interference.

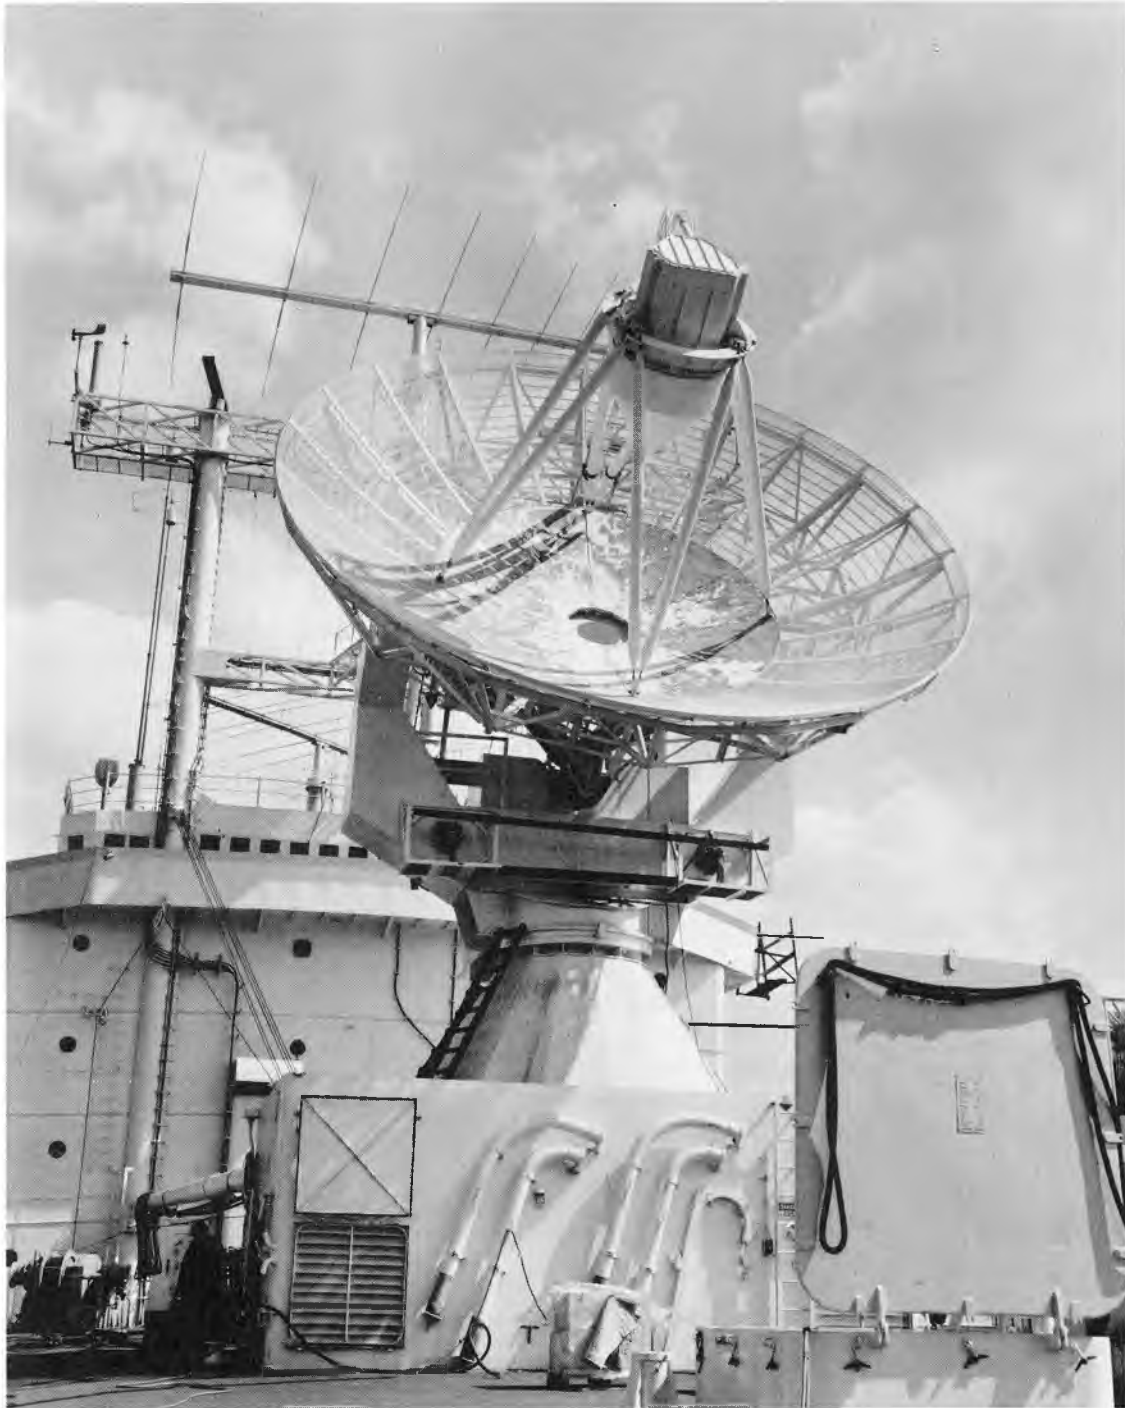
Another problem in the telemetry antenna was traced to a rotary joint assembly in the telemetry antenna feed when the HF transmitters were up. A brush and slip-ring assembly was installed on the rotary joint, solving the problem temporarily, but the brush soon wore out. A more reliable brush assembly will be installed. (see Picture 4 in the Appendix.)

Picture 4. Telemetry Antenna Showing Antenna Feed Box. Inside, a Rotary Joint Assembly Generated Electromagnetic Interference.

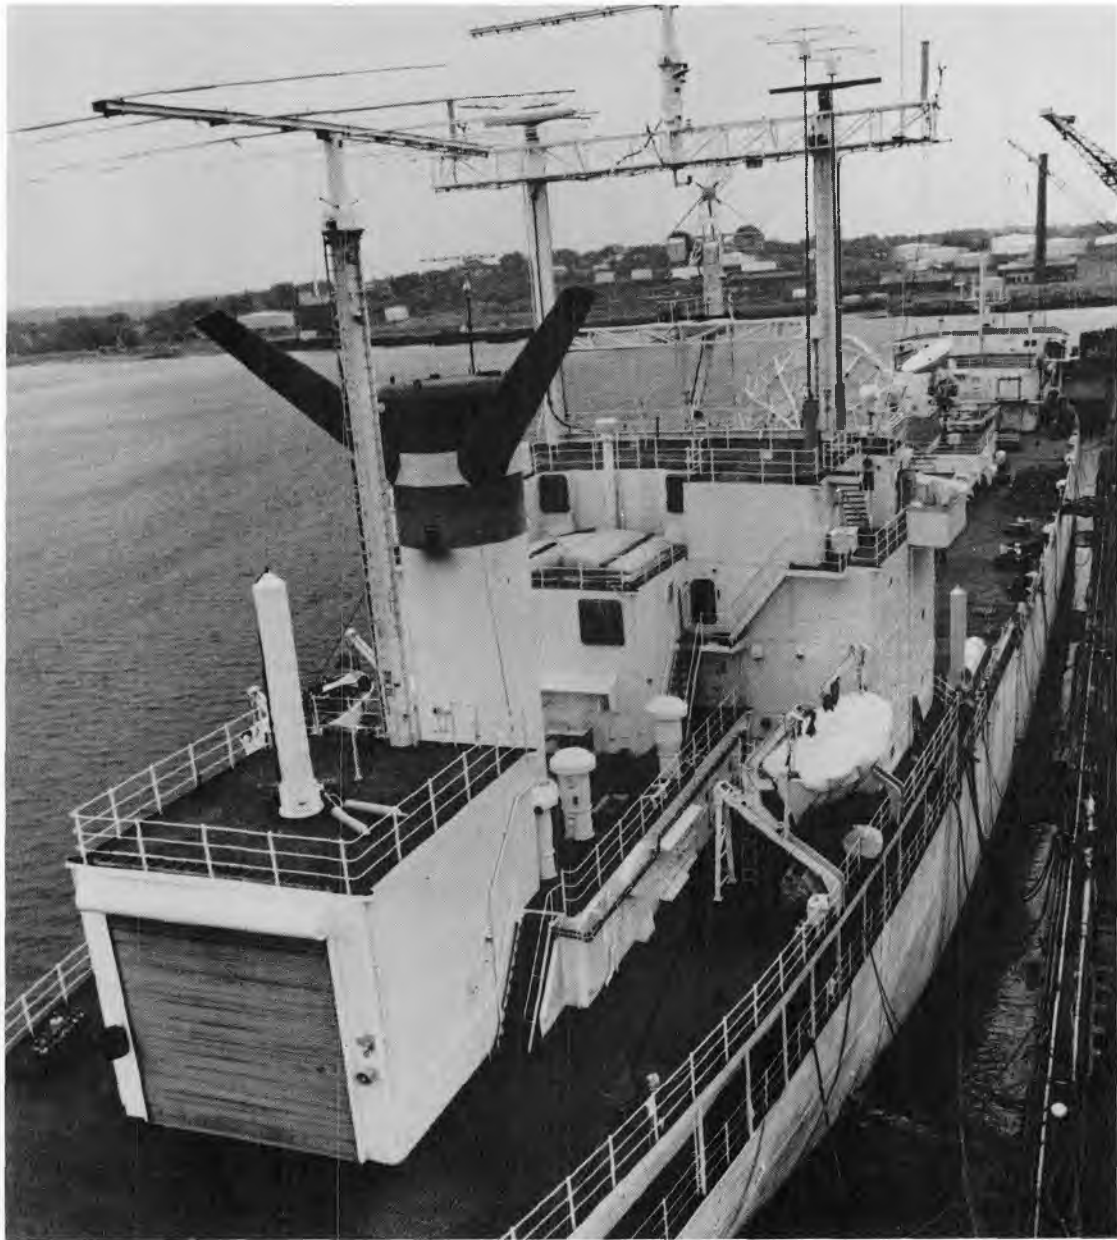
As a result of exposure of the Balloon Deck Log Periodic Antenna to stack gas at about 600° F (see picture 5 in the Appendix), the insulating guy wires that hold the elements parallel melted. Also, a heavy deposit of carbon builds up on the antenna. There have been at least two cases of arcing in the Balloon Deck Log Periodic Antenna, possibly due to these carbon deposits. Normal maintenance now calls for periodic cleaning of this antenna.

Picture 5. Balloon Deck Log Periodic Antenna Located Above Smoke-Stack. Hot Exhaust was Very Detrimental to the Antenna.
