# Collusion and fraud detection on electronic energy meters: a use case of forensics investigation procedures

**Index Terms**—electronic meter, electricity measurement fraud, tampering technique, forensics investigation procedure

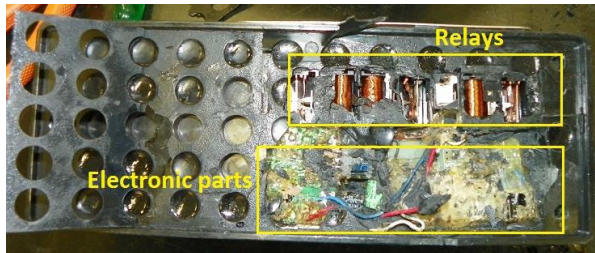
A maintenance team went to the consumer and replaced the faulty meter and the SB. Lab tests revealed non-compatible electrical measurements at the SB, although apparently no violation of the security sealing or device case were visible. After breaking the bottom of the SB case, other than switches were found hidden under the epoxy resin as showed at Figure 4. Non-original electronic devices installed to the original SB device lead to a crime report of device adulteration. A criminal investigation had begun to ascertain a suspicion about energy theft [16].

Figure 4 – The verification switch and abnormal electronic devices hidden under the epoxy resin [15]

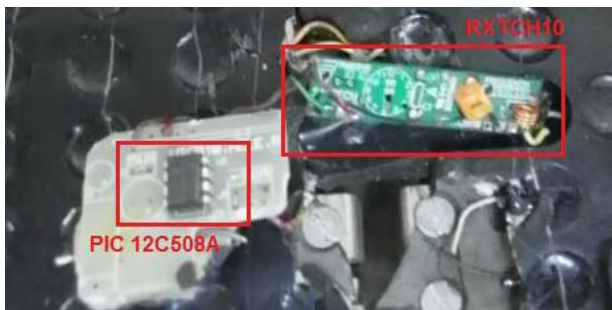
The scientific police team carefully managed to remove the epoxy resin to unveil the electronic circuit configuration and its purposes. The electronic device turned out to be a printed circuit board with a microcontroller and a RF receiver showed at Figure 5.

Figure 5 – Printed circuit board with a PIC 12C508A microcontroller and a RF receiver model RXTCH10 [15].

The PIC 12C508A microcontroller [17] has an 8 bits bus; less than 1kB memory size for program; 25 bytes of RAM; serial port interface and 6 I/O pins. The I/O pins were connected through current buffers and command the triggering of 250V/10A electromechanical relays. The microcontroller serial interface (RX pin) was connected to a circuit board of a RF receiver (RXTCH10 model [18], 433.92MHz RF carrier). The relays were directly connected to the SB contacts. A remote command to the microcontroller can be received by the RF receiver. The microcontroller can send current to current drivers and through the relays the SB switches can be closed. That is, the RF command sets a bypass of the current sensors of the electronic meter. The investigation concluded that a RF transmitter could send the aforementioned command. Such transmitter can be easily adapted from those available to

house applications (gates control, etc.) or alarm devices. The transmission range of these devices is around 150 m.

Using a common RF transmitter and a spectrum analyzer, we established the exact transmission frequency used to command the relays to turn on the SB switches. A remote command is transmitted to the RF receiver inside the SB unit and the relays are triggered to set short-circuits of the meter current sensors.

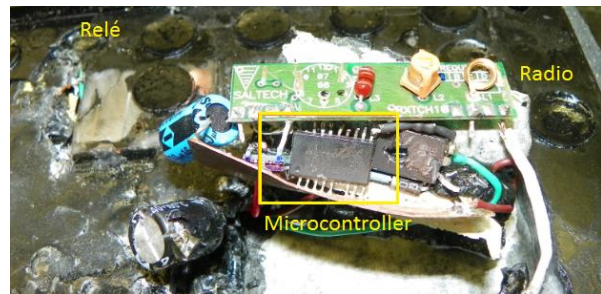
Figure 7 shows a microcontroller not soldered on a printed circuit board (just “wired up”). Although a very amateur built-in circuit, it was efficiently applied to accomplish the fraud.

Figure 7 – printed circuit board and wire-up circuit removed from the epoxy resin
