# Monitoring System for Deep-Seated Landslides using Locally-Developed Tilt and Moisture Sensors: System Improvements and Experiences from Real World Deployment

Electrical and Electronics Engineering Institute, University of the Philippines Diliman, Quezon City, Philippines

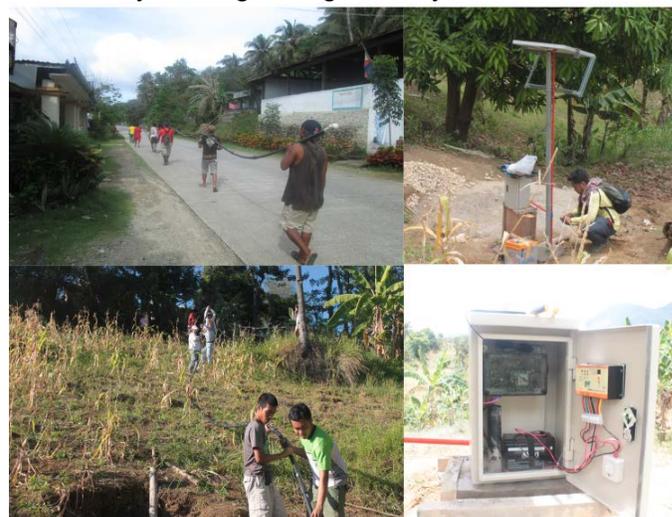
Figure 3. Transporting the assembled sensor column from the location where it is assembled to the deployment site (top left) and installation in the borehole (bottom left). The solar panel used to power up the system (top right) and the enclosure box that contains the battery and other electronics (bottom right).

Figure 3 shows the activities involved in the deployment of the landslide monitoring system. The deployment of the sensor column is highlighted by the spirit of *bayanihan* (communal work), a uniquely Filipino trait. The social aspects of this landslide monitoring program posed another set of serious challenges. The security of the sensor columns is one of the concerns after a series of pilferage events occurred during the first few months of the sensor operation. This unfortunate event did not only result to loss of property, but loss of valuable data as well. Another one is the need of prompt sensor maintenance for the resumption of operation during frequent power interruptions and the replacement of faulty modules of the telemetry and power system. Lastly, there was a need for an immediate on-site monitoring and verification of ground movement during detection of potential movement based on the sensor measurements. Thus, the active assistance of the community members was needed not only in securing and maintaining the monitoring system, but also to improve the efficiency of data gathering and analysis.
